**SOUTHWESTERN COASTAL BASIN
GREENWICH, CONNECTICUT**

**PEMBERWICK DAM
CT 00042**

**PHASE 1 INSPECTION REPORT
NATIONAL DAM INSPECTION PROGRAM**

FEBRUARY, 1980

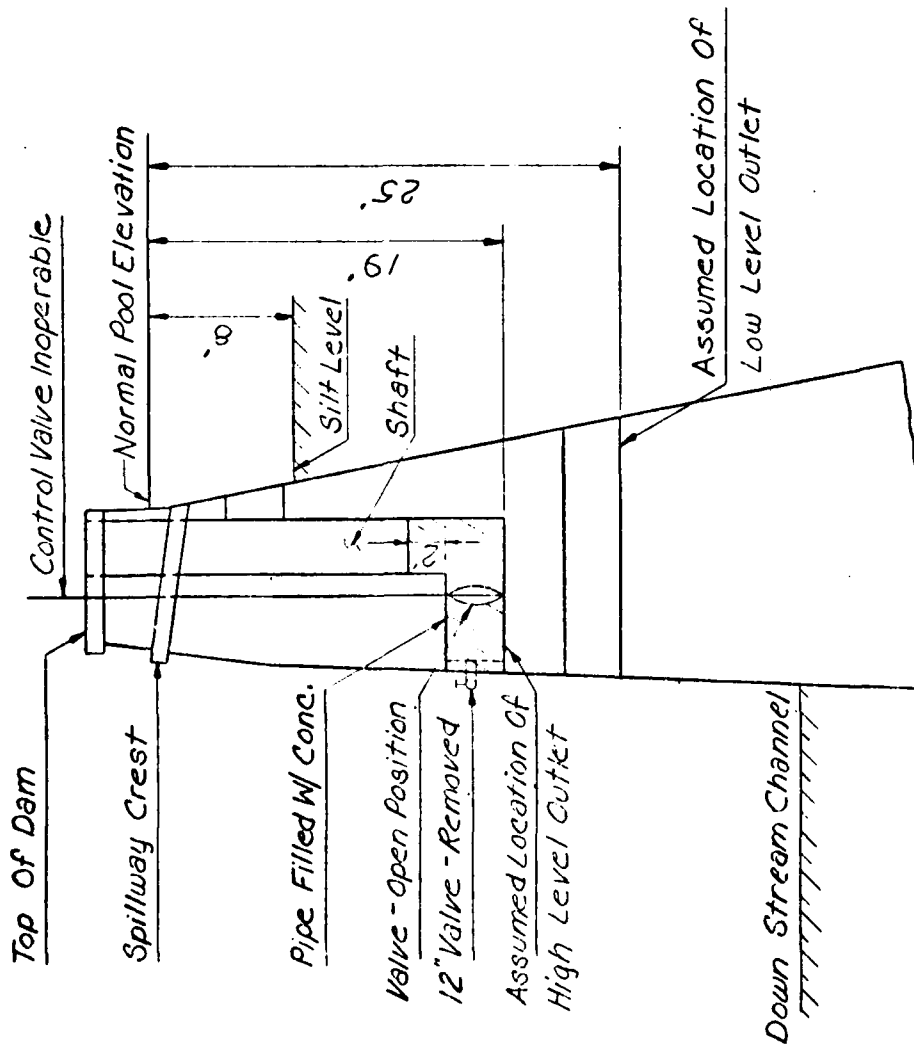
SECTION SHOWING OUTLETS

The outlet works, consisting of pipes through the dam, have been inoperable for many years. The high level outlet was sealed in 1978 to control leakage and the inlet for the low level outlet is suspected to be below the present sediment level.
